Restorative dentistry using the Isolite System

By Mark A. Hyman, DDS, MAGD

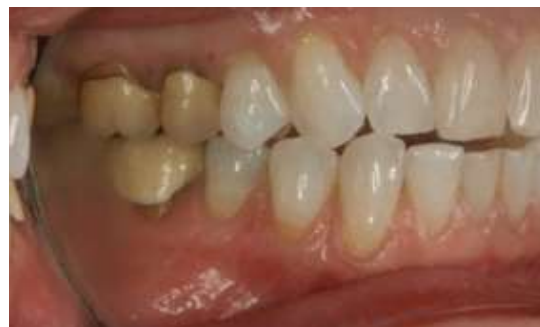
Figure 1. Pre-operative view

The patient, a 60-year-old woman, presented with old porcelain-fused-to-metal crowns with open margins, as well as failing composite restorations. Her chief complaints were sensitivity around the margins of the restorations and the fact that the crowns were yellow and did not match the colour of her teeth (Fig. 1). After a full examination and discussion with the patient, she was scheduled for treatment visits to replace these upper and lower restorations.

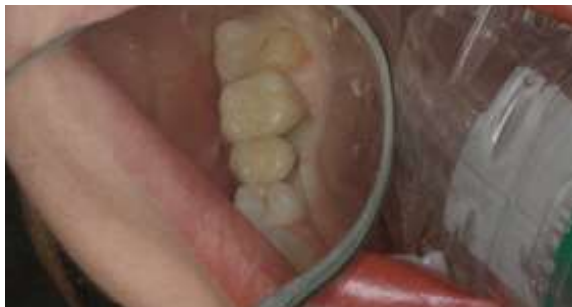
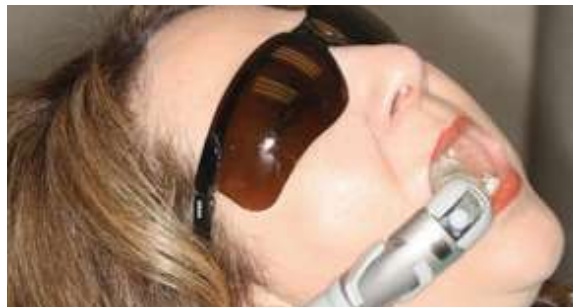
The Isolite device was then placed in position (Figs. 2 and 3). The Isolite mouthpiece provides additional patient safety by obturating the

10,000 hour LED light with 5-levels of illumination plus cure-safe mode. The Isolite system’s mouthpiece is available in multiple sizes, and has plastic flexible flanges buccally as well as palatally and lingually, providing for good simultaneous isolation of the upper and lower quadrants.

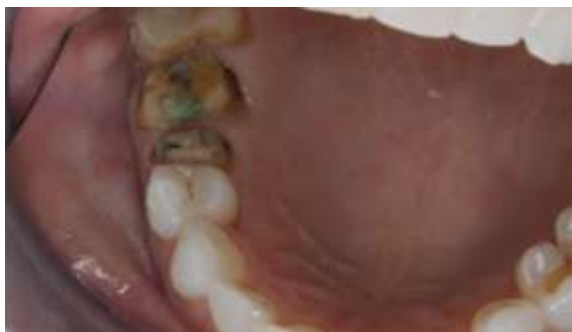
throat, minimising the chance of materials from entering the patient's airway. The defective crowns in teeth Nos. 14 and 15 were then removed and the preparation forms finalised (Fig. 4). Replacement composite resin restorations were completed in teeth Nos. 4 and 5 at the same visit. The expanded function assistant then packed gingival retraction cord and took digital impressions of the preparations in teeth Nos. 14 and 15 using an intra-oral camera, and the crowns were milled chairside using LAVA resin composite blocks (3M ESPE, Minneapolis, MN). The digitally designed crowns were tried in and the margins, occlusion, shape, and shade checked (Fig. 5). A pre-cementation radiograph was also taken to check the margins. The Isolite mouthpiece may be left in during imaging and is not affected by radiography process.

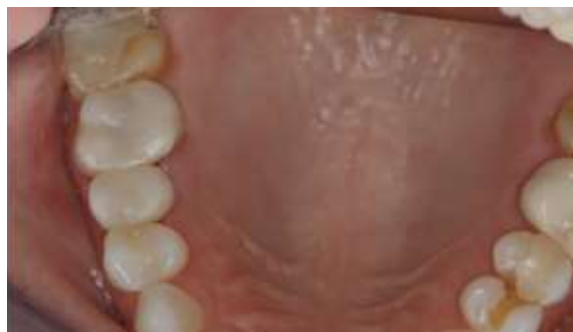
light-cured (Fig. 6). The selected shade of the dual-cured luting agent was then placed in the crowns, the crowns seated, and the cement cured. Two curing lights were used during each stage of the adhesive procedure, one buccally and one palatally, to speed up curing. The margins were checked for excess cement, and the occlusion was checked. The patient was very happy with the aesthetic results (Fig. 7).
